National Highway
Traffic Safety
Administration

Case Vehicle (A): 1999 Dodge
 Type: Ram 1500 Quad Cab, 4x2 pickup
 Driver: 33-year-old male
 CDC: 71-FLEW-4

Case No.: 22100
Case Date: 14-10-2008 Dodge
Type: Four-Wheel Drive/4WD, 4x4 pickup
Driver: 30-year-old male

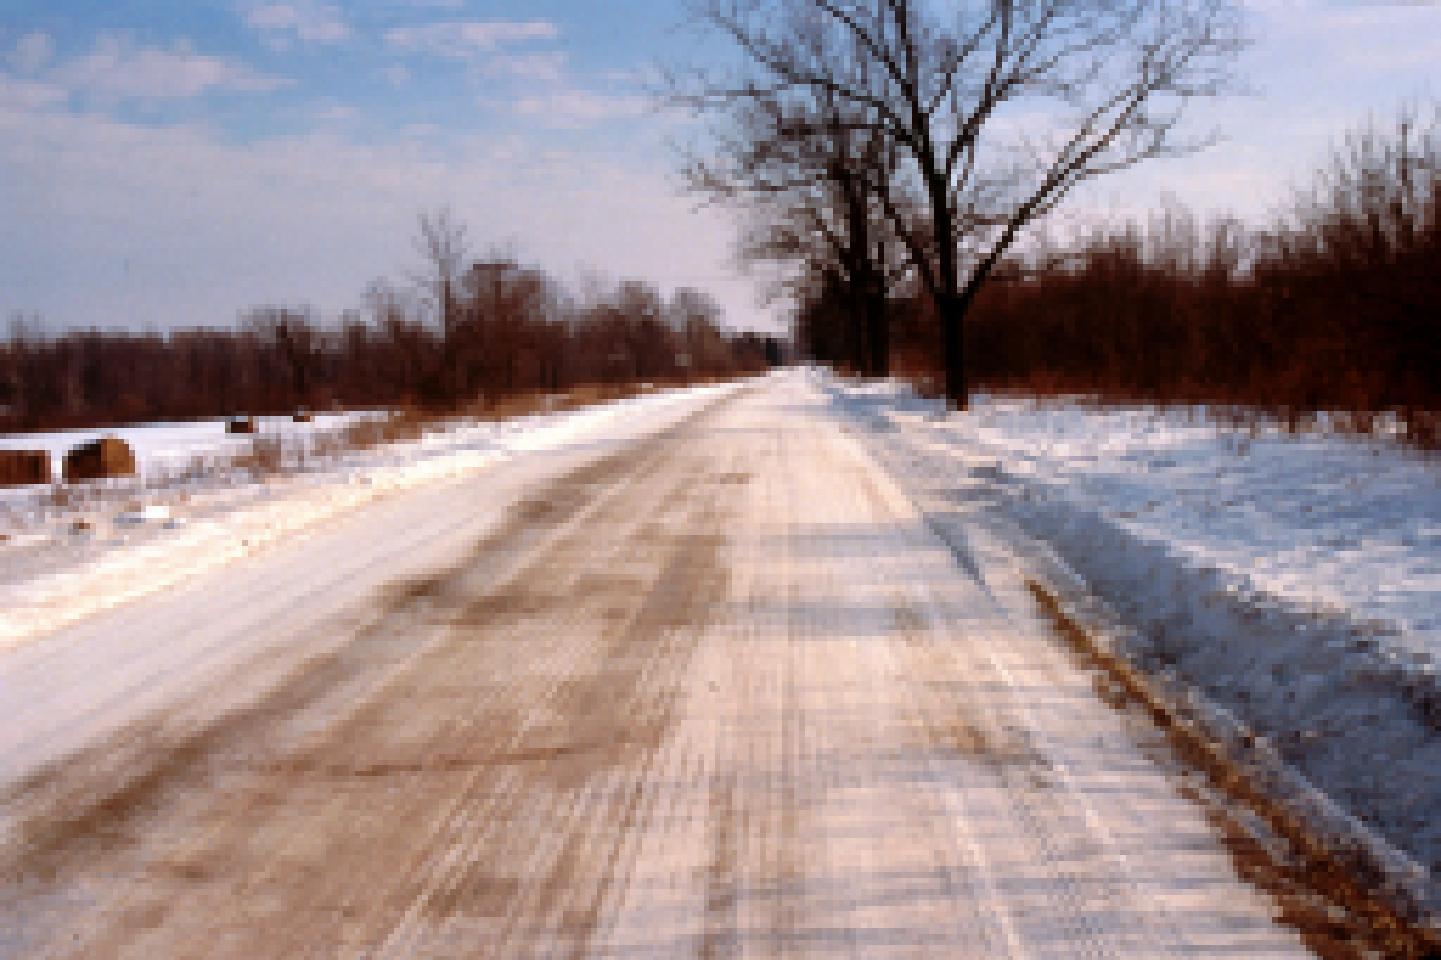
PN 22100#1

(Slides 1, 2) On a cloudy night, case vehicle (A) was traveling east at an unknown speed on a gravel road in a rural area. The road surface was dry, it was dark, and the speed limit was 55 mph (89 kph). The driver had been drinking alcoholic beverages, and lost control of the vehicle on the gravel road. (Slides 3, 4, 5, 6, 7 and 8) The vehicle exited the south edge of the road and struck a 50-cm diameter tree with its left-front corner. After the impact, the vehicle rotated counterclockwise and came to rest on the road facing southwest. The unbelted driver was completely ejected out the driver-side window frame of the vehicle and was found lying on the ground. He was transported to the hospital by ambulance and the vehicle was towed from the scene due to damage. The driver's blood alcohol content was .22 percent.

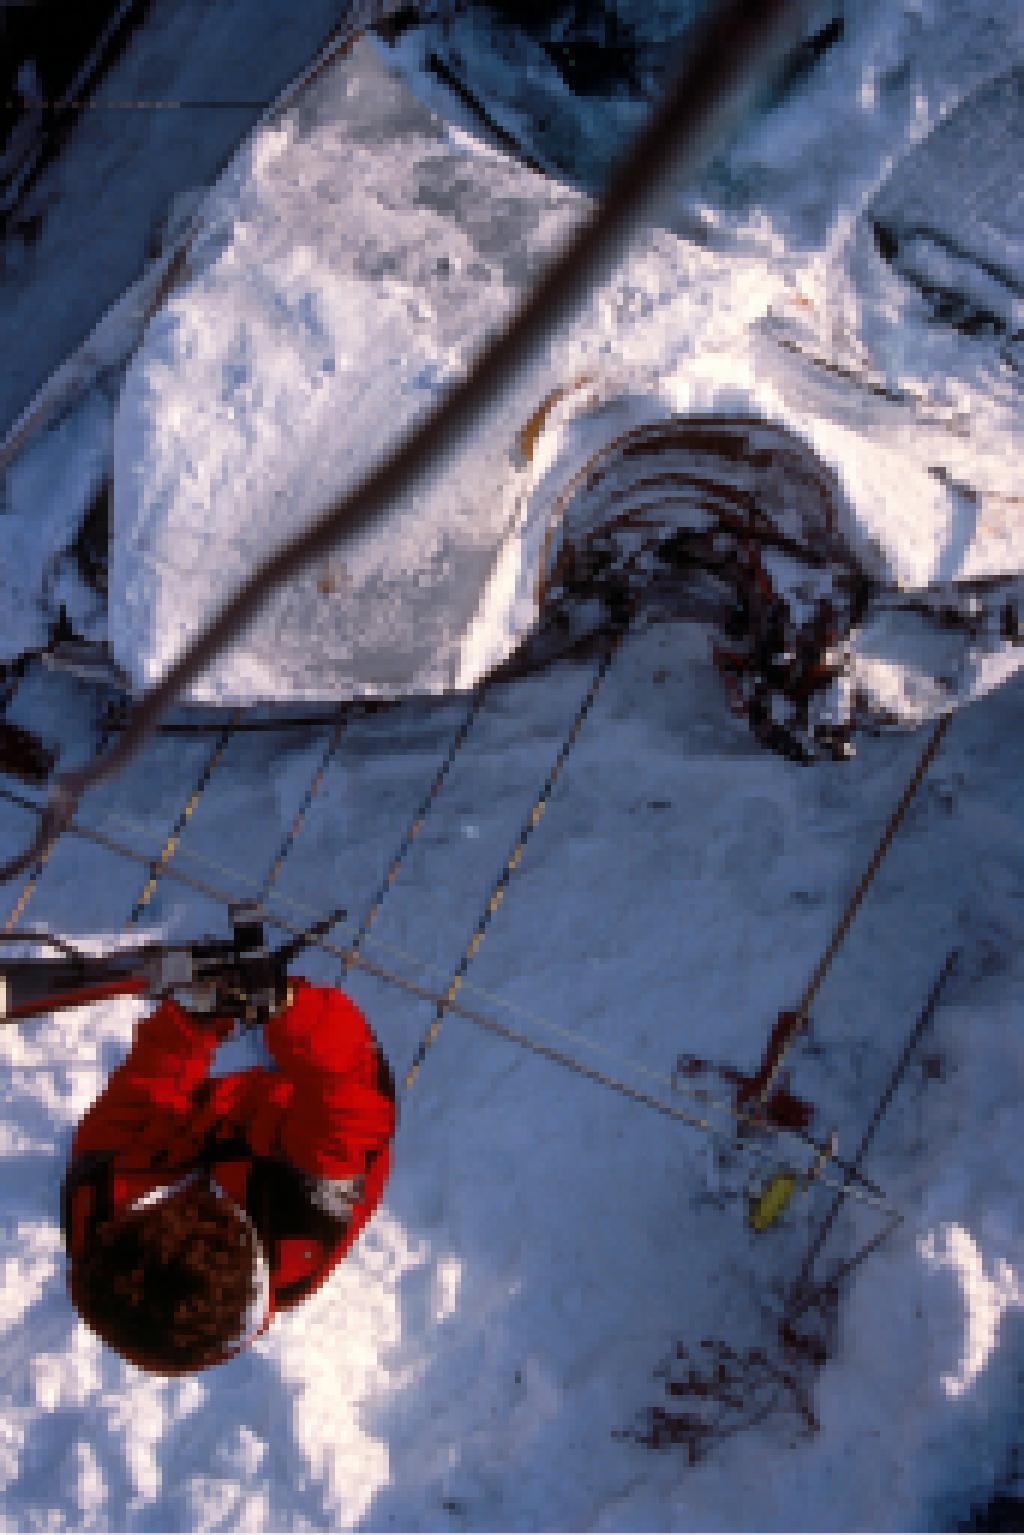
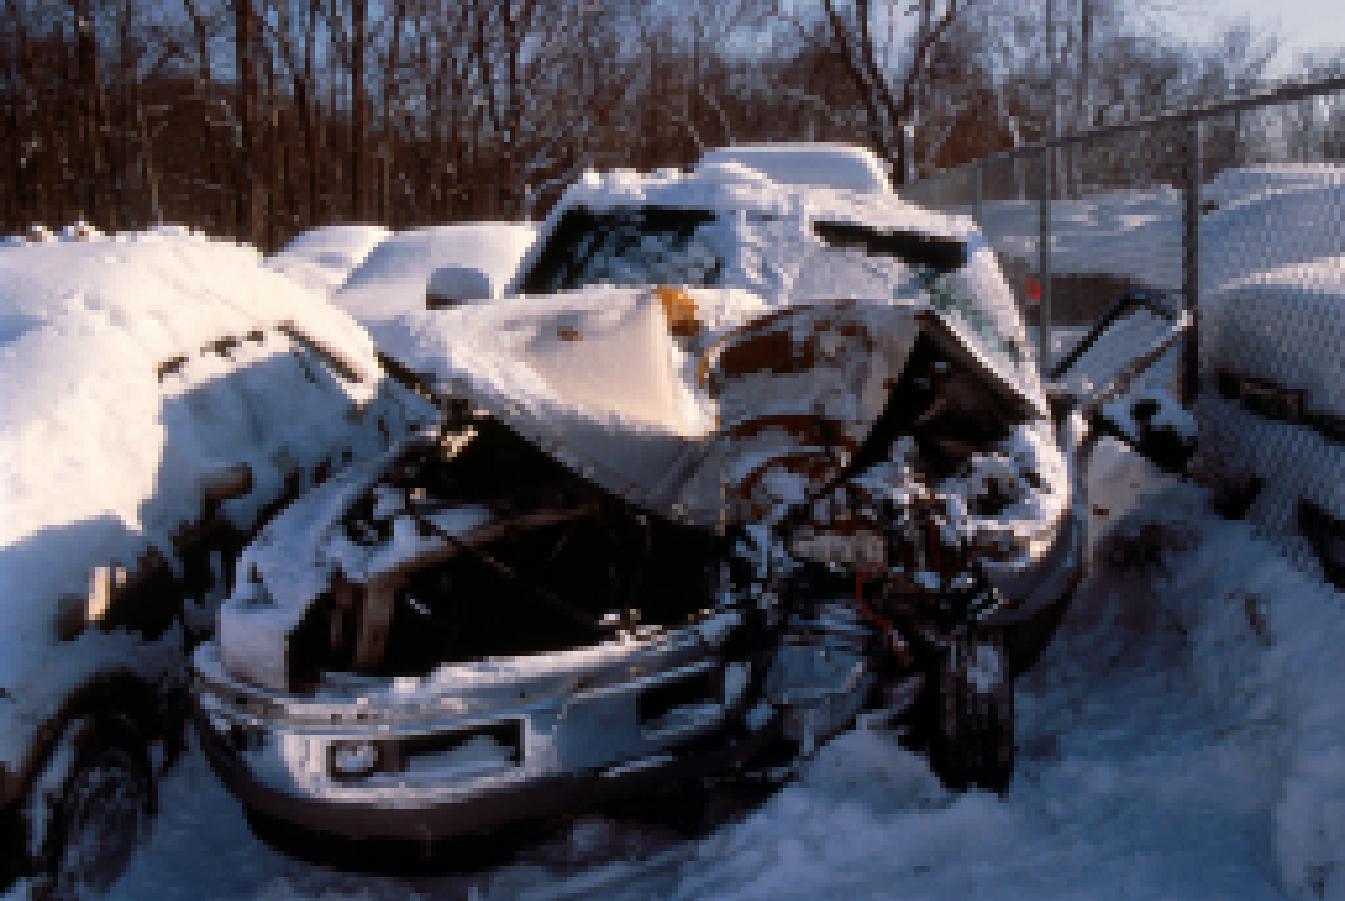
PN 22100 #9

(Slides 9, 10) The direct damage to the front of case vehicle (A) began at the left-front bumper corner and extended 54 cm across the front, resulting in 30-percent vehicle overlap. The maximum crush was 78 cm to the left-front bumper corner.

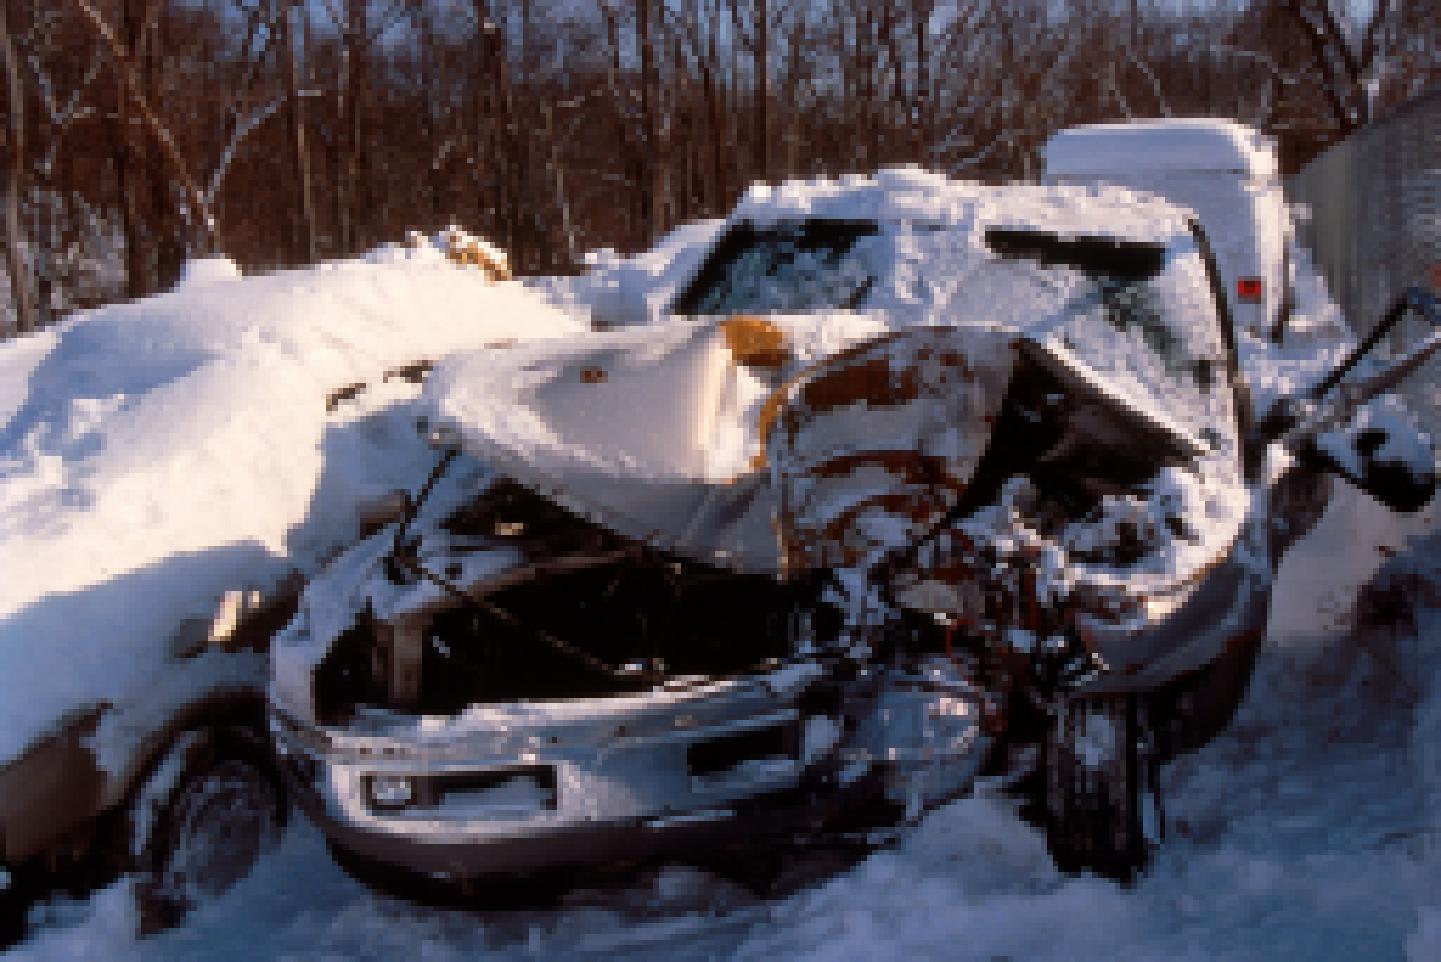
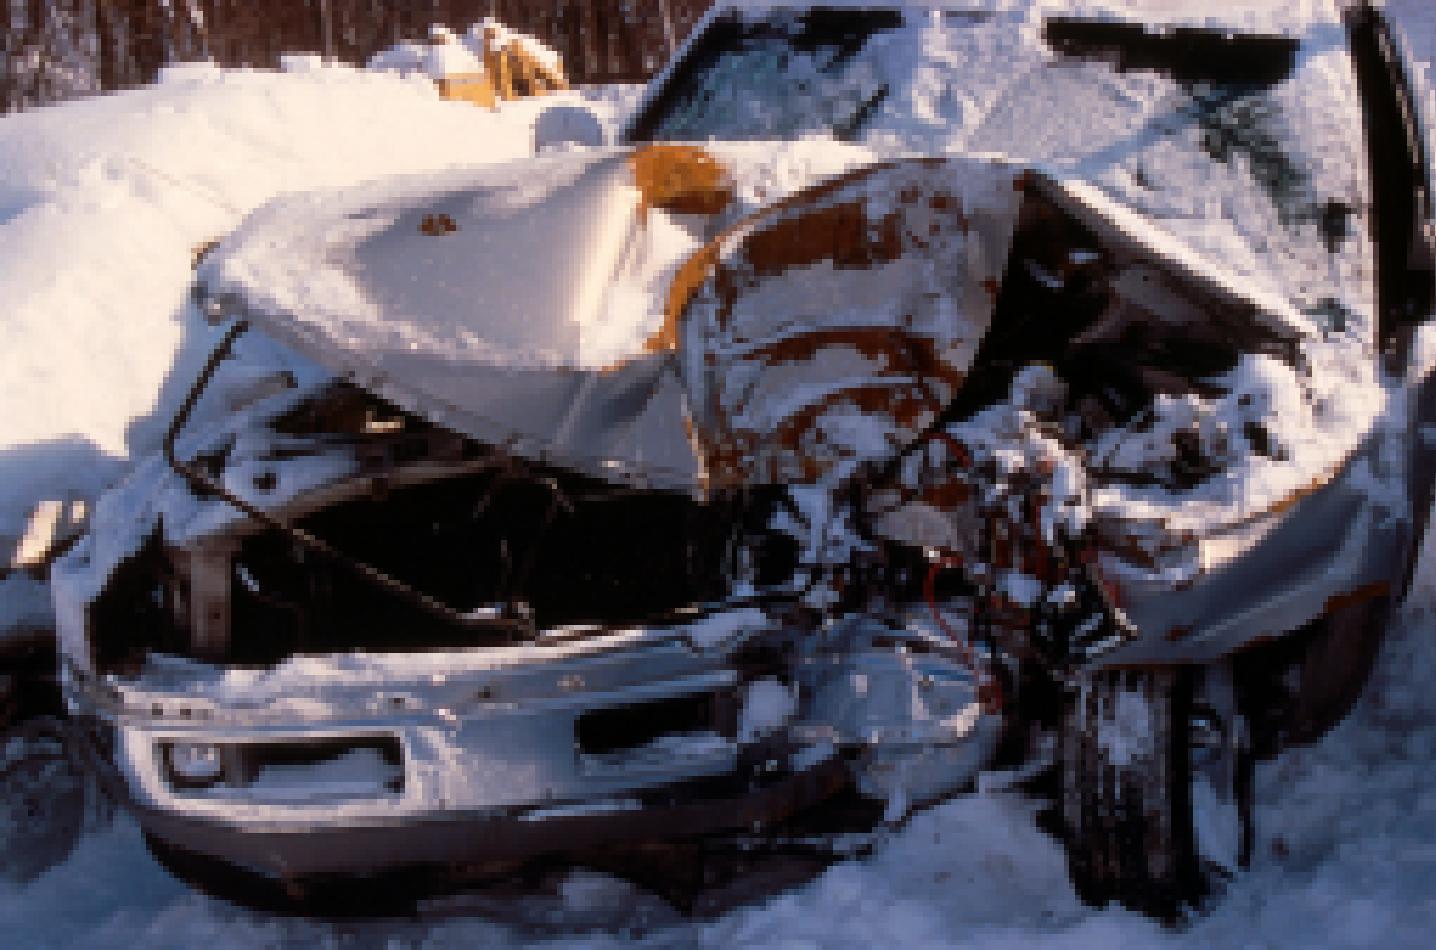
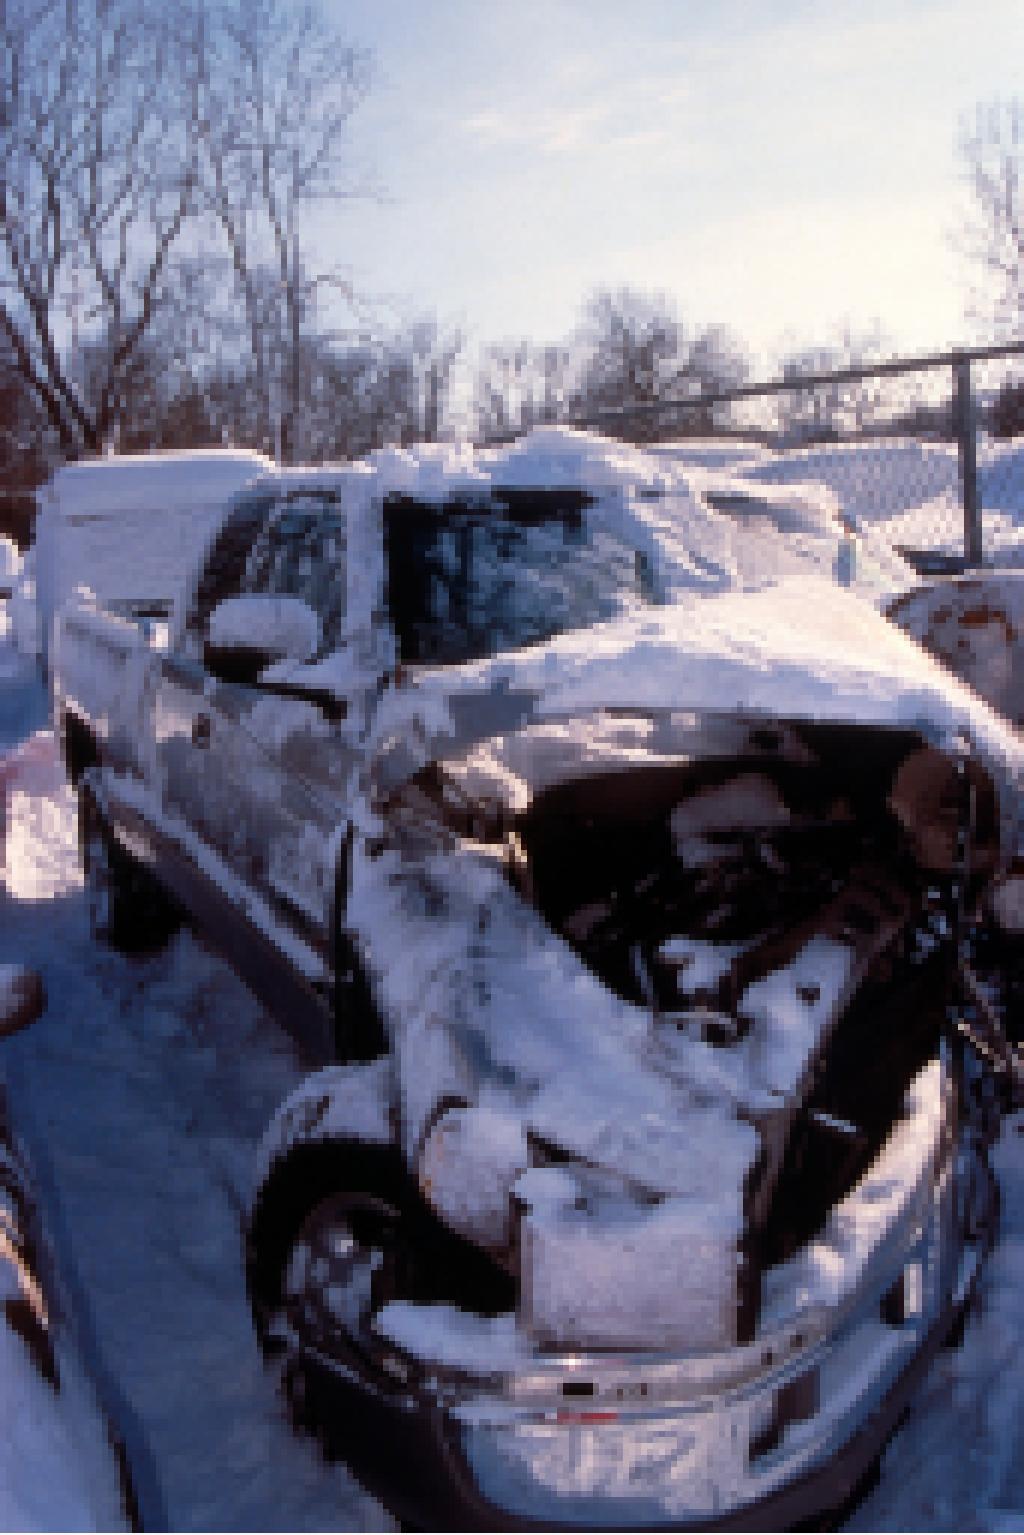
PN 22100 #17

(Slides 17, 18 and 19) The front bumper and grille were severely damaged, both headlights were broken, and the front end was shifted to the right. (Slides 20, 21) The hood was severely crushed

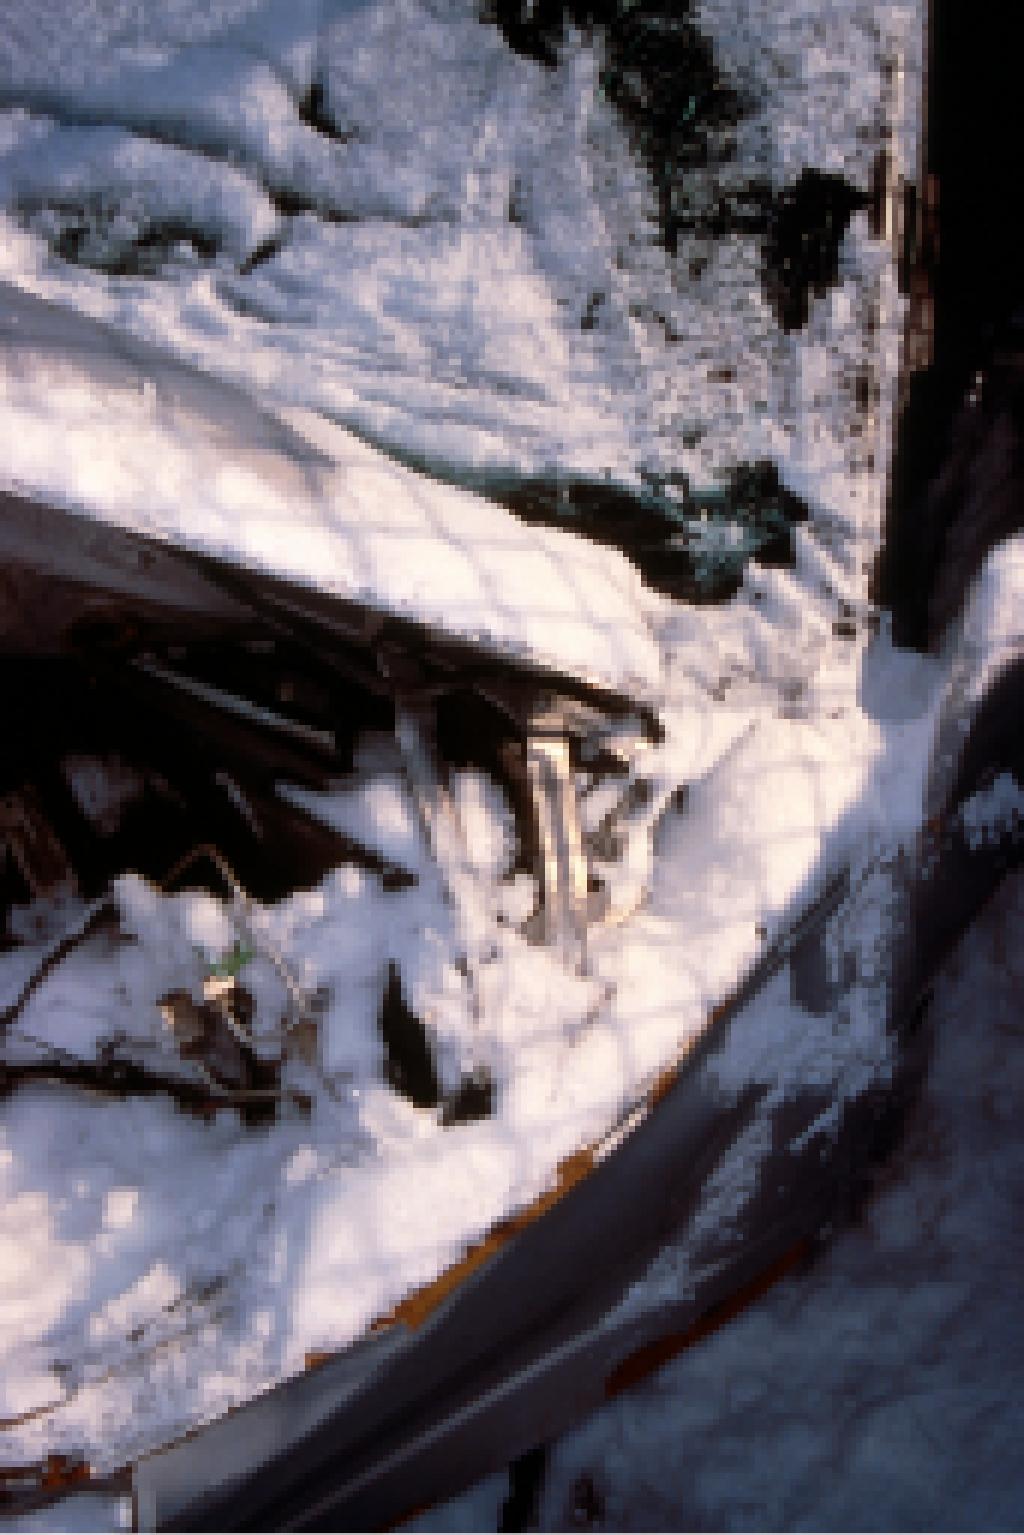
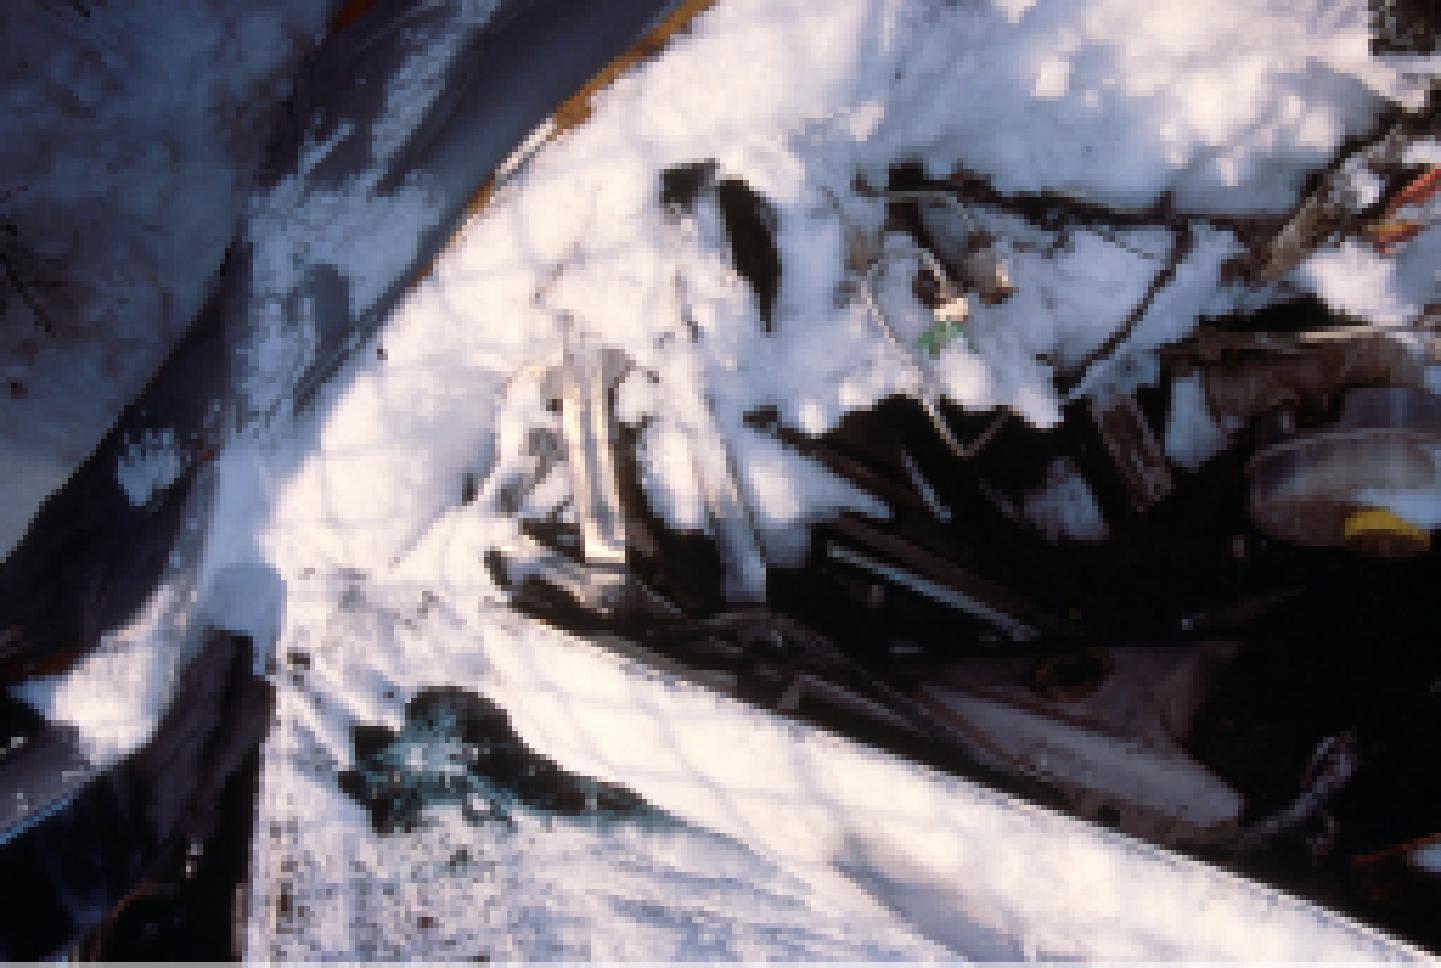
PN 22100 #20

and pushed rearward, the damaged hood latch was jammed, and both hood hinges were damaged, but not separated. The rear edge of the hood was elevated, but it did not contact the windshield. (Slide 22) The entire windshield was cracked.

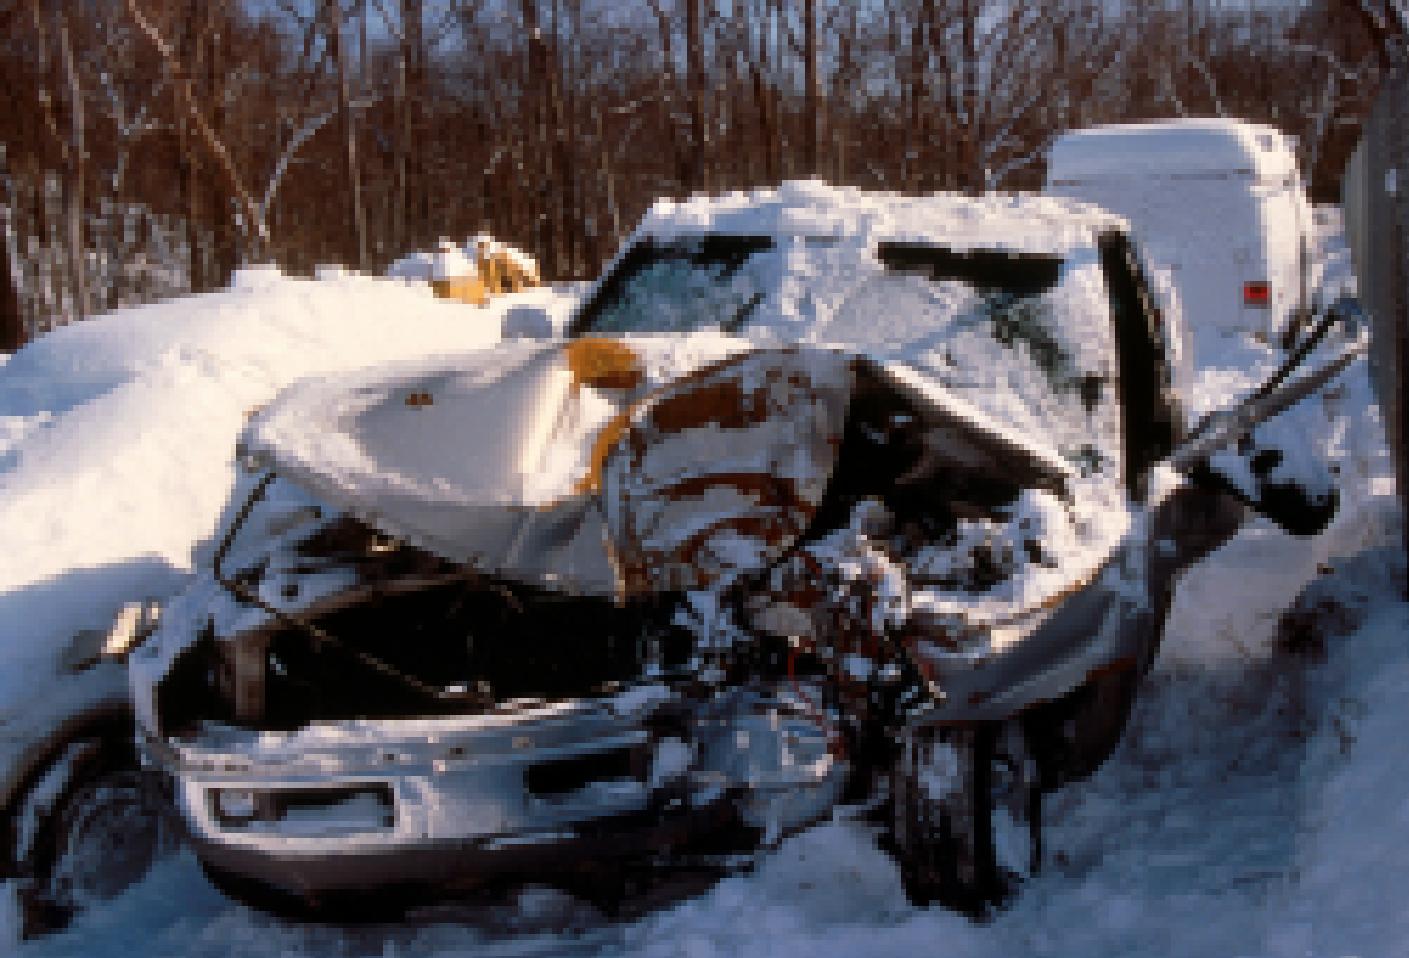
PN22100 #23

(Slide 23) On the left side, the fender was crushed and shifted to the right, and the left upper and lower A-pillars were deformed. (Slide 24) The left-front wheel was damaged and the left wheelbase was decreased by 4 cm. (Slides 25, 26 and 27) Also, both left-side doors were damaged and jammed closed, the driver door window glass was broken, and the upper half of the door window frame was severely bent outward and down from driver loading during ejection.

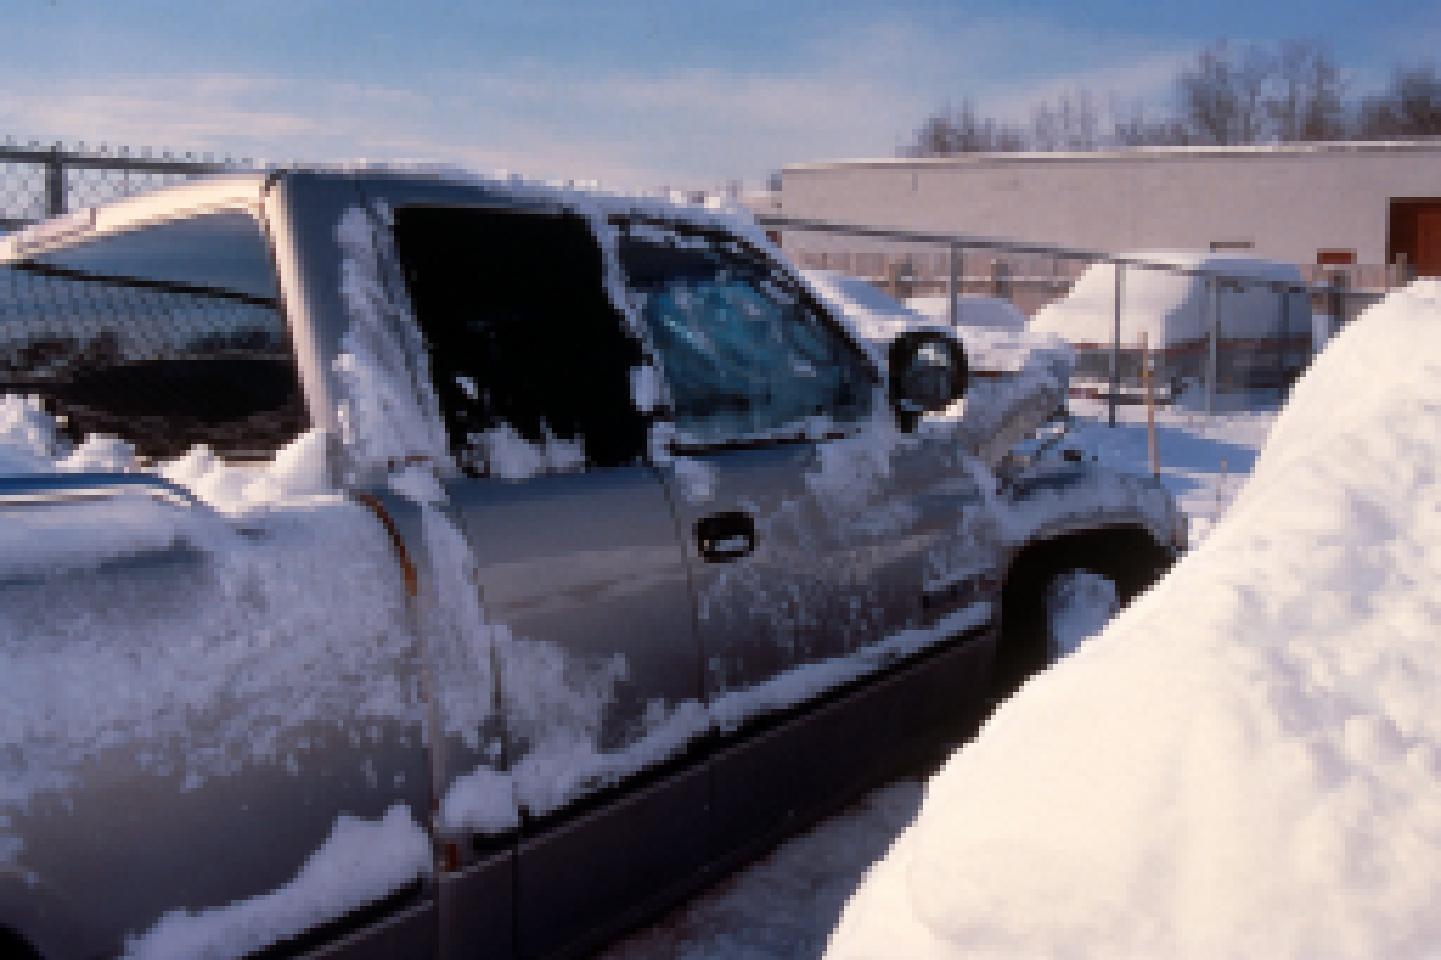
PN 22100 #31

(Slide 30) On the right side, the fender was deformed and shifted to the right, and the right-front wheel was damaged. (Slides 31, 32 and 33) There was no other damage to the right side and no change in the right wheelbase.

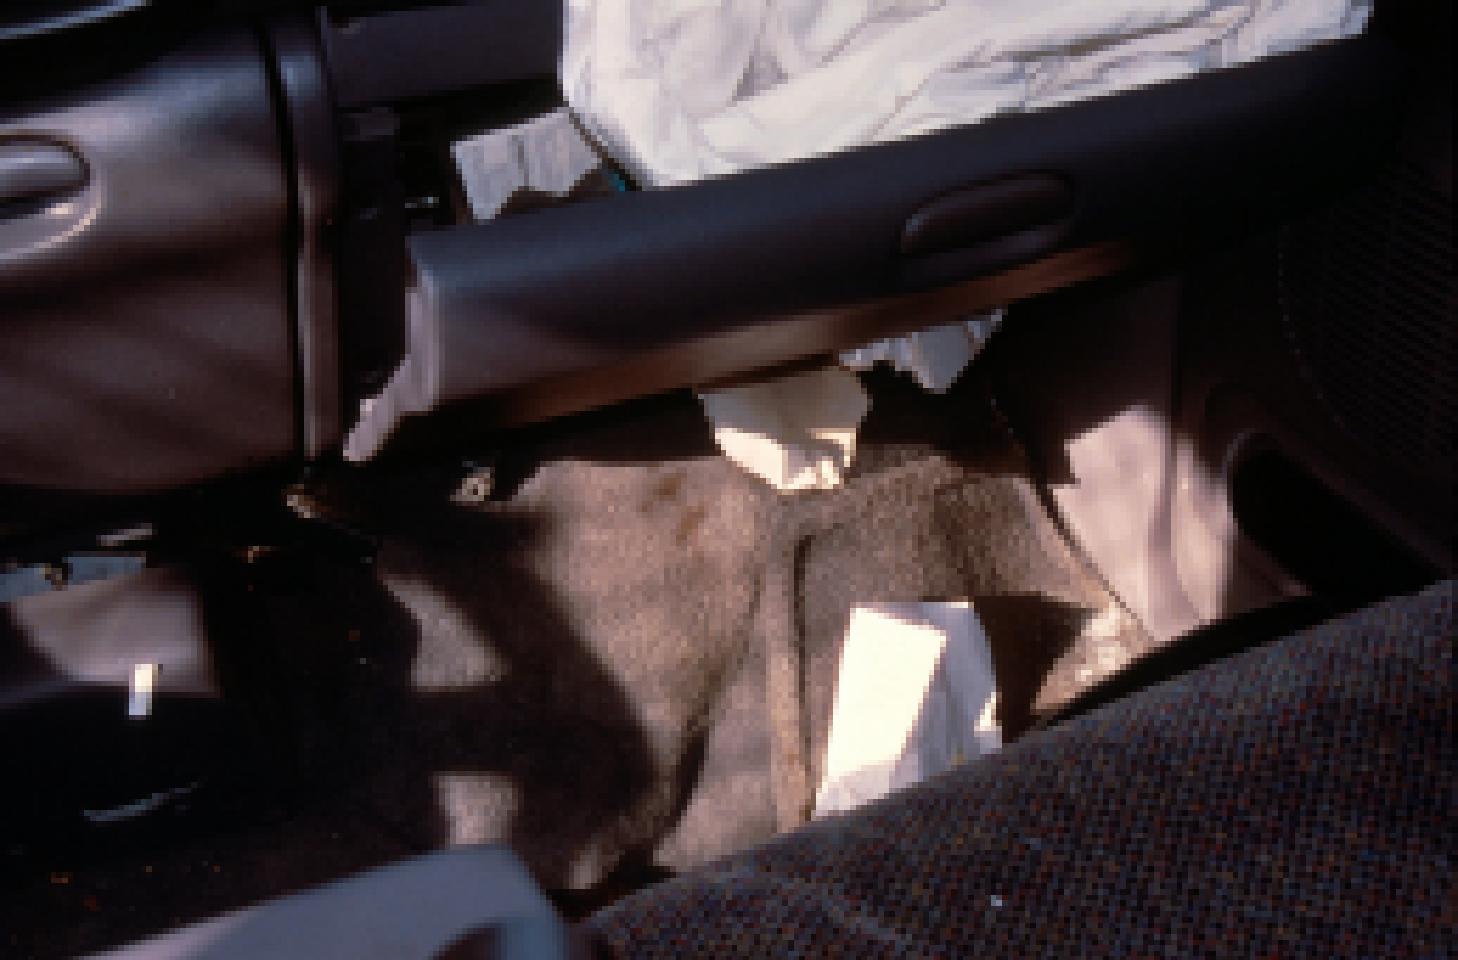
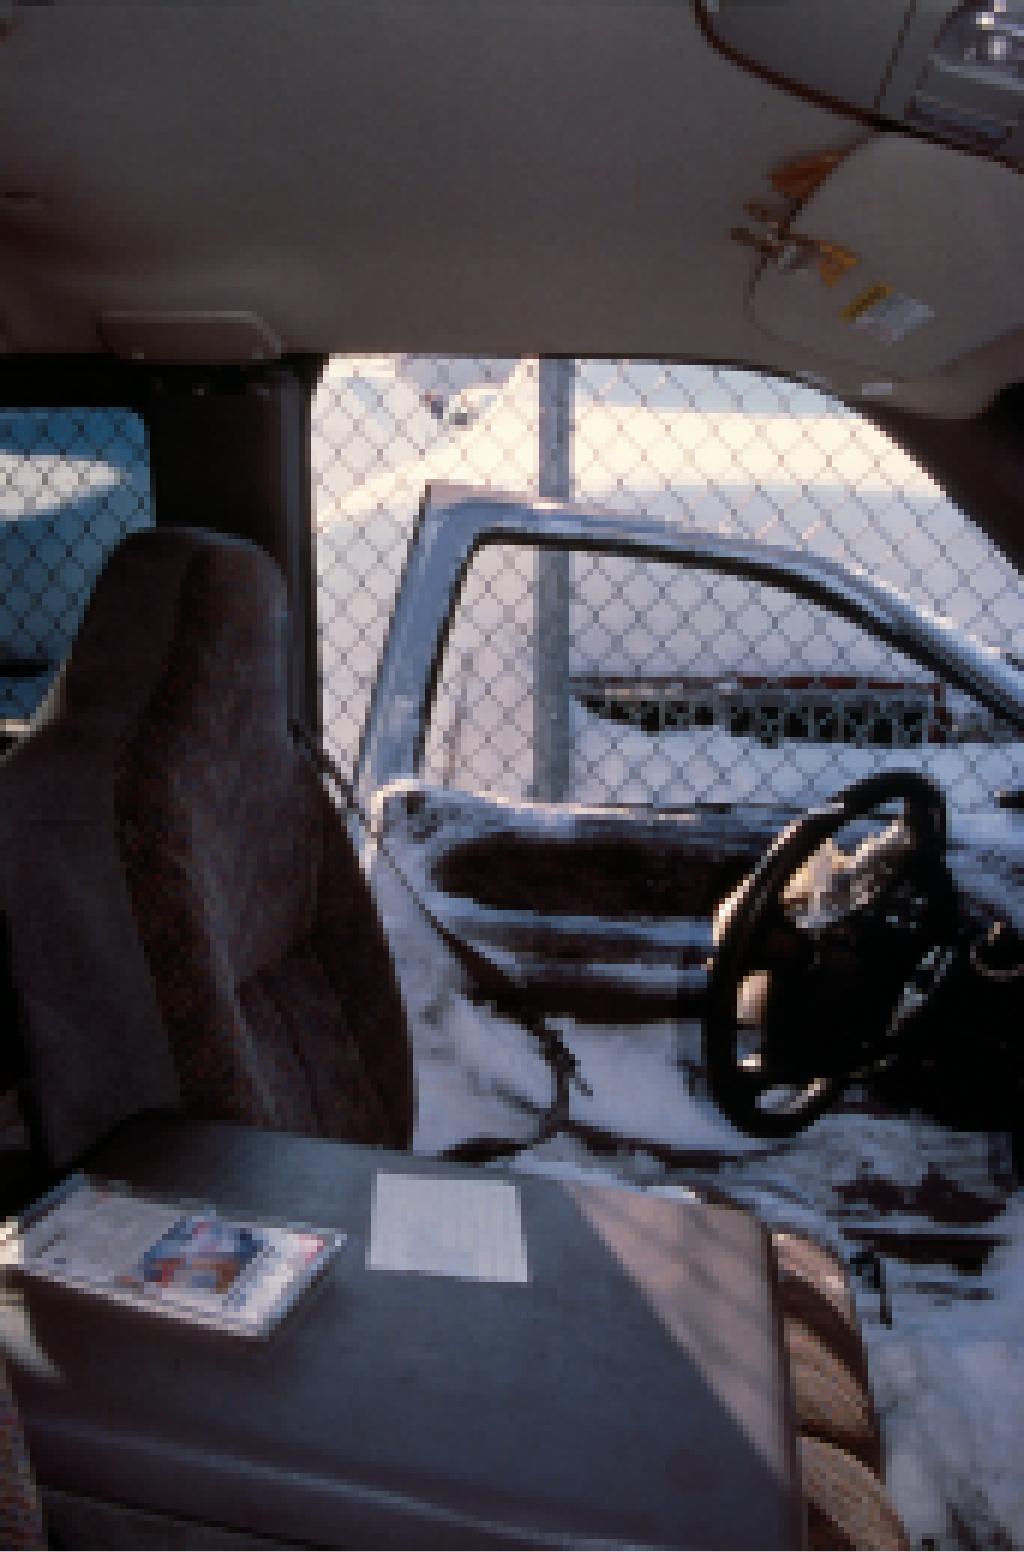
(Slide 34) This vehicle is equipped with steering-wheel and passenger frontal-impact airbags, which deployed during this frontal impact. (Slides 35, 36) There was no damage to the airbags, and no visible contact marks on the airbag skins. (Slides 37, 38 and 39) The bottom half of the steering-wheel rim was bent and the shear capsules were completely separated, allowing the steering column to rotate down and to the left. (Slides 40, 41) The upper and mid portions of the instrument panel, and the knee bolster were damaged. (Slide 42) The driver door interior, and door window frame were damaged and severely bowed outward from driver contact. (Slides 43, 44) Also, the driver door hardware and door armrest were deformed, and the door window glass was broken. (Slide 45) There was no visible damage to the roof headlining, although there was a possible scuff mark just above the A-pillar. (Slide 46) There was damage to the vertical console area and the control knobs on the instrument panel. (Slides 47, 48, 49 and 50) There was no damage to the glove box area and no deformation to, or contacts on, the roof area or the left or right A-pillars. Both front seatbacks were rotated forward and the driver seat adjuster was jammed. (Slide 51) There was no damage to the rear-seat area. (Slides 52, 53) The following intrusions were noted and measured:

Location	Component	Distance (cm)	Direction
driver	toepan	25	to rear
	floor	10	up
right-front	toepan	34	to rear
